***NIST Workshop on Standards Development
for the Use of Fiber Reinforced Polymers for the
Rehabilitation of Concrete and Masonry Structures,
January 7-8, 1998, Tucson, Arizona.
Proceedings***

Typical Manufacturing Flaws in FRP Retrofit Applications

by Gary F. Hawkins, Eric Johnson and James Nokes
The Aerospace Corporation

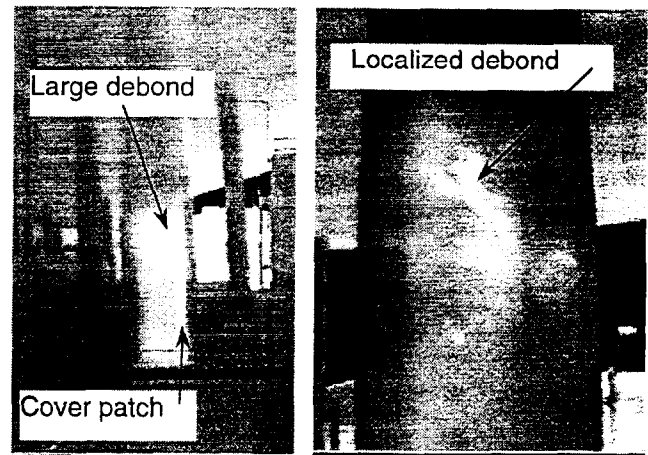
Figure 4 shows an area with an approximately 75 cm by 25 cm debond. This can be caused by the spray-on adhesive partially curing before the straps are cinched tightly. If the shells cannot slide with respect to each other, then they cannot tighten themselves to the column and a large debond results.

Figure 4. Large debond in a prefabricated shell
